# LONG-TERM STORABILITY OF PROPELLANT TANKAGE

TECHNICAL REPORT AFRPL-TR-71-20

LABORATORY TEST REPORT  
PROJECT 305805FRJ

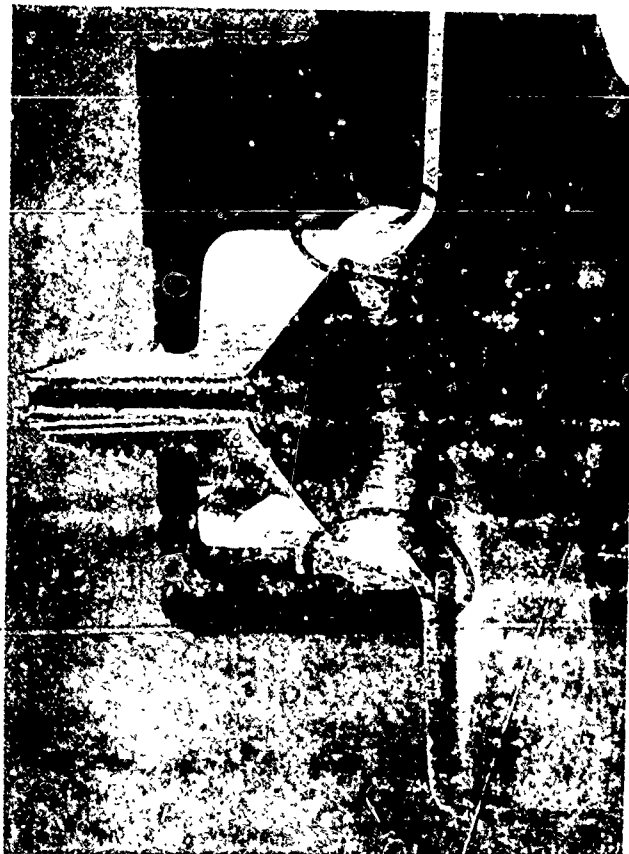
1. <u>MACROEXAMINATION</u> : All of the tanks were lightly etched over their entire external surfaces. Cracks were readily evident at the top and bottom boss welds of all of the tanks (Fig. 2). Tank #75 had a build-up of corrosion products at the top boss weld area. (Fig. 1) The internal surfaces of the tanks were not etched. A through crack (Figs. 4 & 5) was observed in Tank #75 opposite the corrosion products on the external wall. None of the other tanks had through cracks.

2. <u>LEAK CHECK</u> - The tanks were pressurized to 25-30 psi with GN <sub>2</sub> and leak tested with a soap solution. The only tank that leaked was #75 despite the fact that all of the tanks had developed cracks as gross as the one shown in Figs 2 & 3.

The cracks (Fig 2) on the four tanks submitted to the Met Lab appear identical to the cracks formed on the 6061 aluminum alloy tanks referenced above. In addition, para. IV (3), (4) of this report describe the same failure mechanism, i.e, intergranular corrosion.

Figure 2. Typical Crack (1.5X)

Figure 3. Typical Crack (1.5X)
